RESTORING LAKE PEDDER: A GEOMORPHOLOGICAL PERSPECTIVE ON RECOVERY PROSPECTS AND LIKELY TIME SCALES

KIERNAN, K., 2001: Restoring Lake Pedder: A geomorphological perspective on recovery prospects and likely time scales; *in*: Sharples, C., (ed.), *Lake Pedder: Values and Restoration*, Occasional Paper No. 27, Centre for Environmental Studies, University of Tasmania, p. 153 - 176.

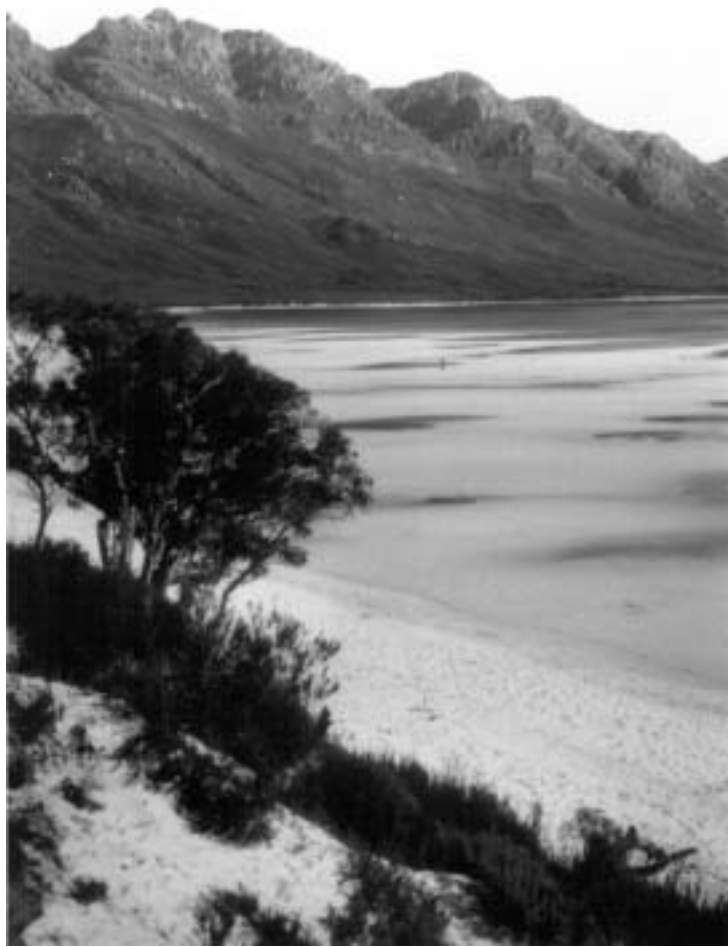
Figure 1: Some key elements of the Lake Pedder landscape: the seasonally exposed lake bed; the beach; the naturally-eroded windward western face of the dune mass, and, in the background, the gentle slopes at the foot of the Frankland Range (photo: K. Kiernan).

features that added to the scientific importance of Lake Pedder and for many gave the area its principal appeal: the sand bed; the bar and mega-ripples; small scale ripple bedforms; Pedder Pennies; the beach; and the dunes (Figure 1). From a geomorphological viewpoint the restoration of Lake Pedder cannot be considered a practical possibility unless these elements either: (1) remain intact or, (2) if they are damaged, have the capacity to regenerate either naturally or with assistance; and (3) are not at risk of serious damage as a consequence of draining the dams following two and a half decades of inundation since the Huon and Serpentine dams were filled. The Lake Pedder landform community additionally comprises other genetically-related landforms such as the glacial phenomena that extend from the slopes of the Frankland Range and across the floor of the Serpentine River Valley, and various fluvial channels including the meandering Serpentine River and braided Maria Creek channels (Johnson 1972, Timms 1992, Kiernan 2001).

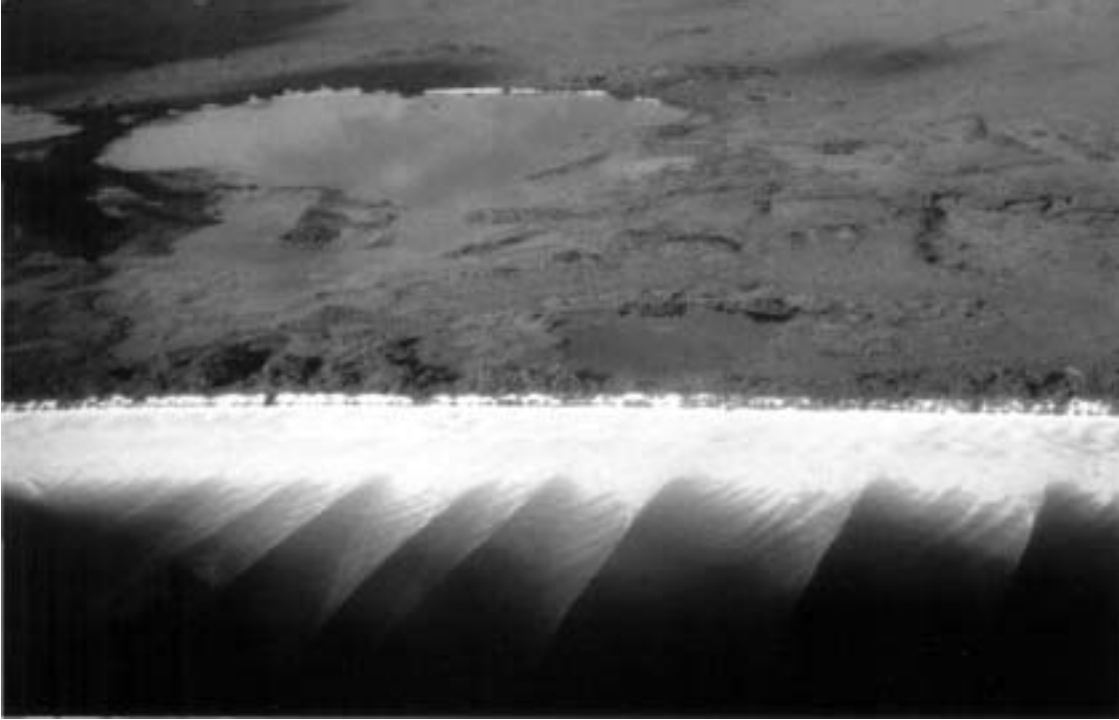
Figure 2: Mega-ripples at the eastern end of Lake Pedder. Note the continuous natural erosion scarp along virtually the full length of the dune face behind the beach, and the very great breadth of the dune mass behind the foredune, reaching to the Maria Lakes system and beyond it (photo: K. Kiernan).

The mega-ripples on the floor of the original lake were the product of a slow clockwise circulation of the water in the lake (Figure 2). Their termination at the margin of the bar reflects the importance both of the materials in transit, the broad topography of the lake bed, and water depth. Bottom currents might have been modified since filling of the storage, at least locally, potentially impacting on the mega-ripples. However, Tyler *et al.* (1993, 1996) have demonstrated that mega-ripples which appear broadly consistent with those in the natural lake still occur in that position beneath the much deeper waters of the artificial impoundment. The mega-ripples in the natural lake were not fossil features but were the product of contemporary postglacial processes of sand transport by circulating lake water. Hence, even if they had been destroyed totally, or if they have been damaged, they could be expected to reform rapidly within a very short span of time, probably as little as a year or two, once the original lake levels were re-established.

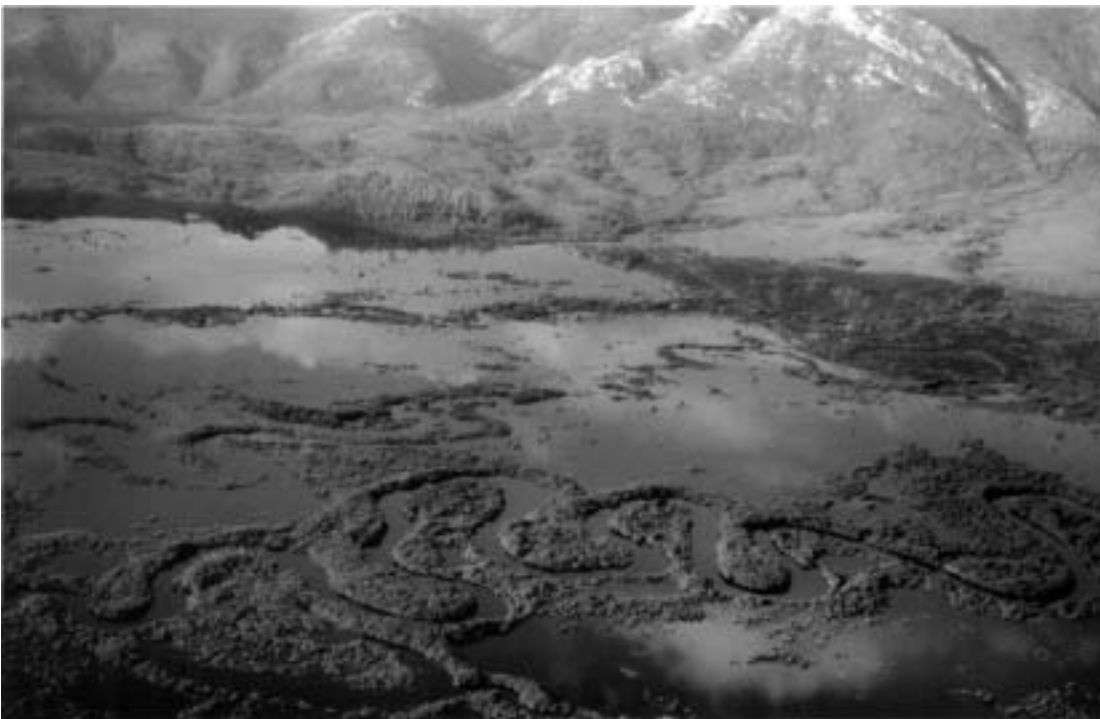
Figure 3: The Serpentine River channel during filling of the Reservoir in 1972. No evidence of riverbank collapse is evident, nor any evidence of trees being torn down by waves and the banks levered apart as the water rose. This is consistent with evidence gained during inspection of older artificial reservoirs when drawdown has exposed their floors to reveal intact streambanks with dead trees or stumps still in growth position upon them (photo: K. Kiernan).

The most dangerous period for all the Pedder landforms was as the dams were filling (Figure 3). During the filling process the water began to impinge higher on slope profiles than was naturally the case and water depth was sufficiently shallow for potential erosion of lakeside landforms by waves. Under these conditions some accelerated removal of sand from the already naturally truncated windward face of the lunette system was observed. This seemed alarming to lay bushwalkers at the time but needs to be considered more analytically and in context with geomorphological processes and the natural erosion

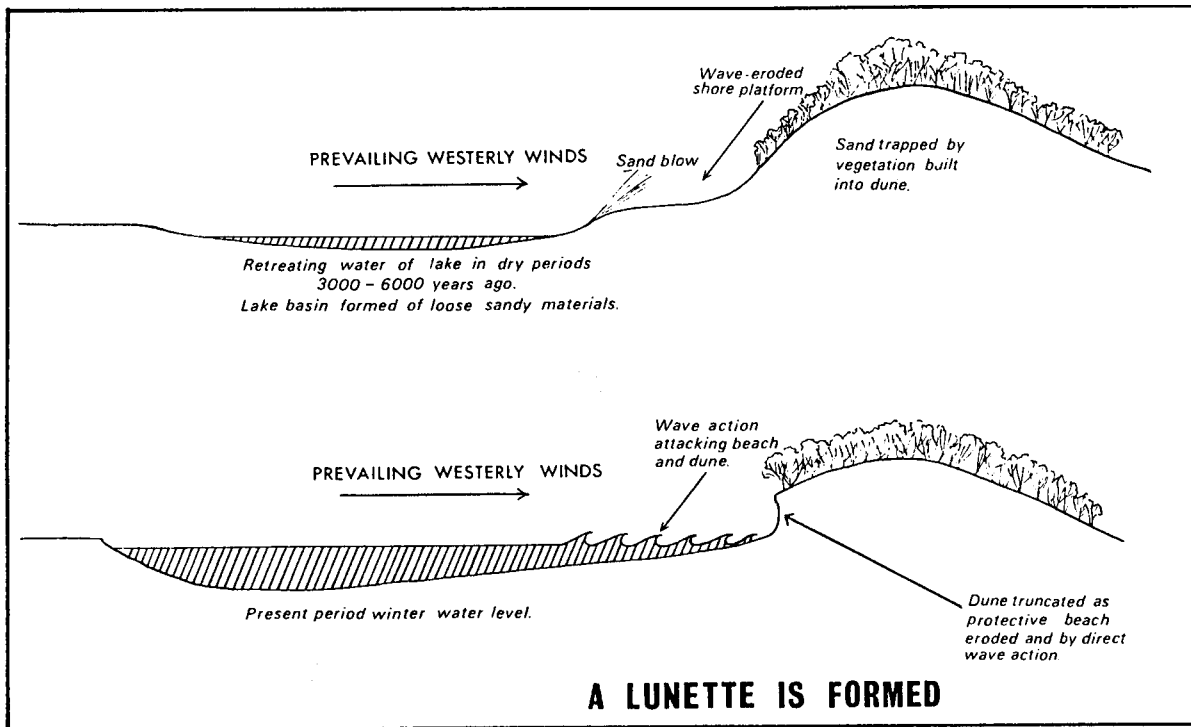
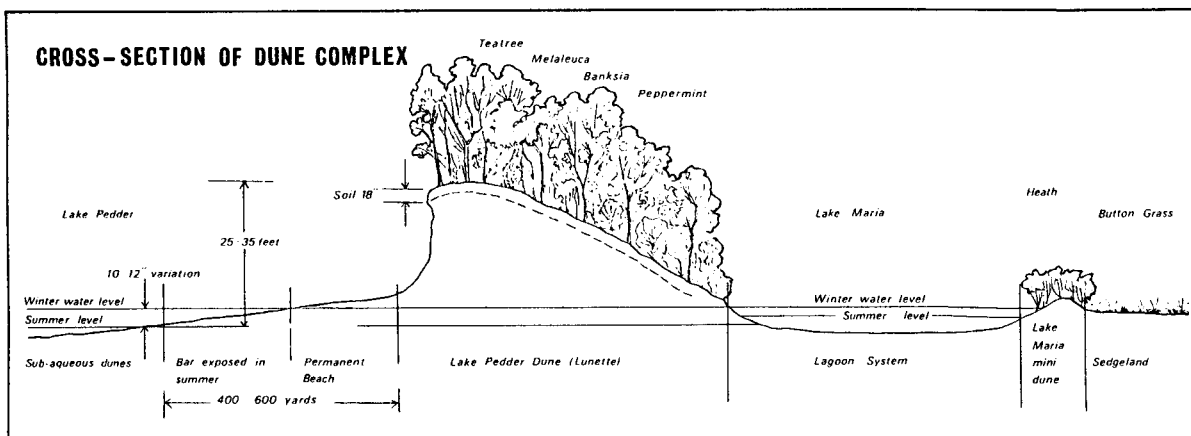
Figure 4: Morphology and natural evolution of the Pedder dune face. Higher water levels in winter and wave action driven by the prevailing westerly winds caused natural erosion of the dune face every winter, causing near continuous exposure of the sand face behind the beach (from Johnson 1972, p. 28).

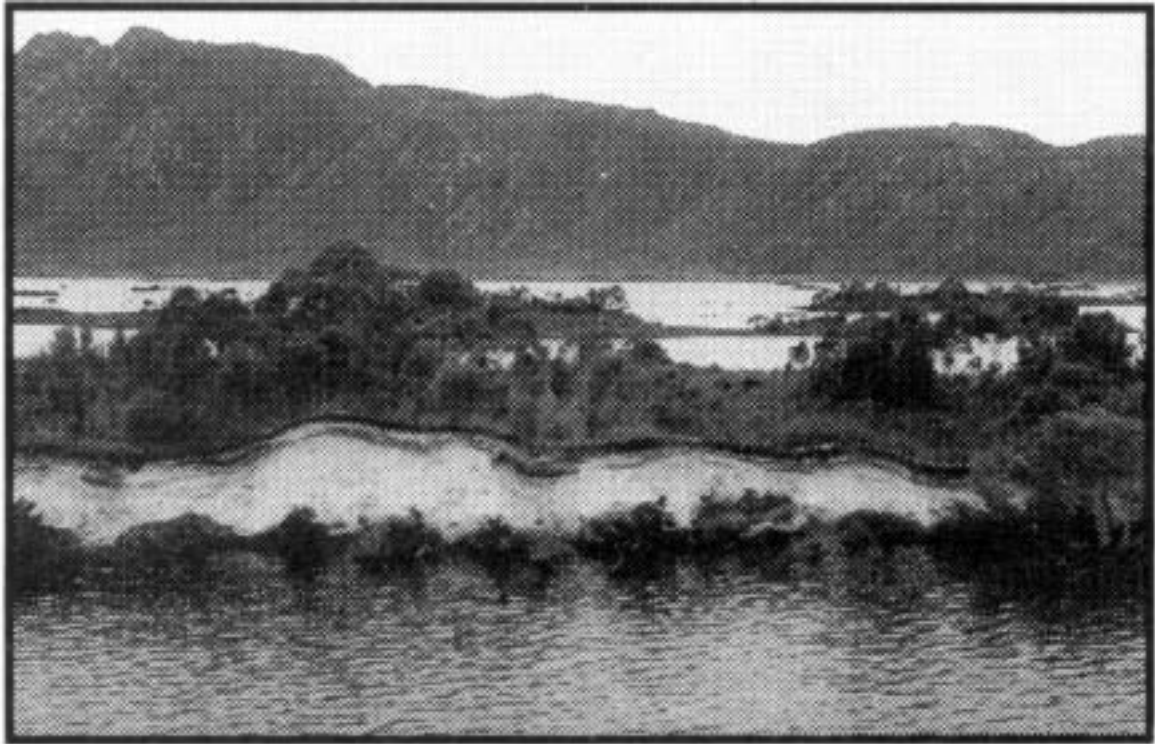
Figure 5a: Photograph of the dune face taken during filling of the reservoir in July 1972 when the water level was 296.5 metres, well below the new lake's final level of 308m. This photograph was used by the pro-dam lobby in the 1970s in an attempt to promote the idea that the dunes had been destroyed, and was employed again in a misleading press campaign in 1995 (see this volume p. 7). It shows trimming but no fundamental change to the natural morphology of the dune face.

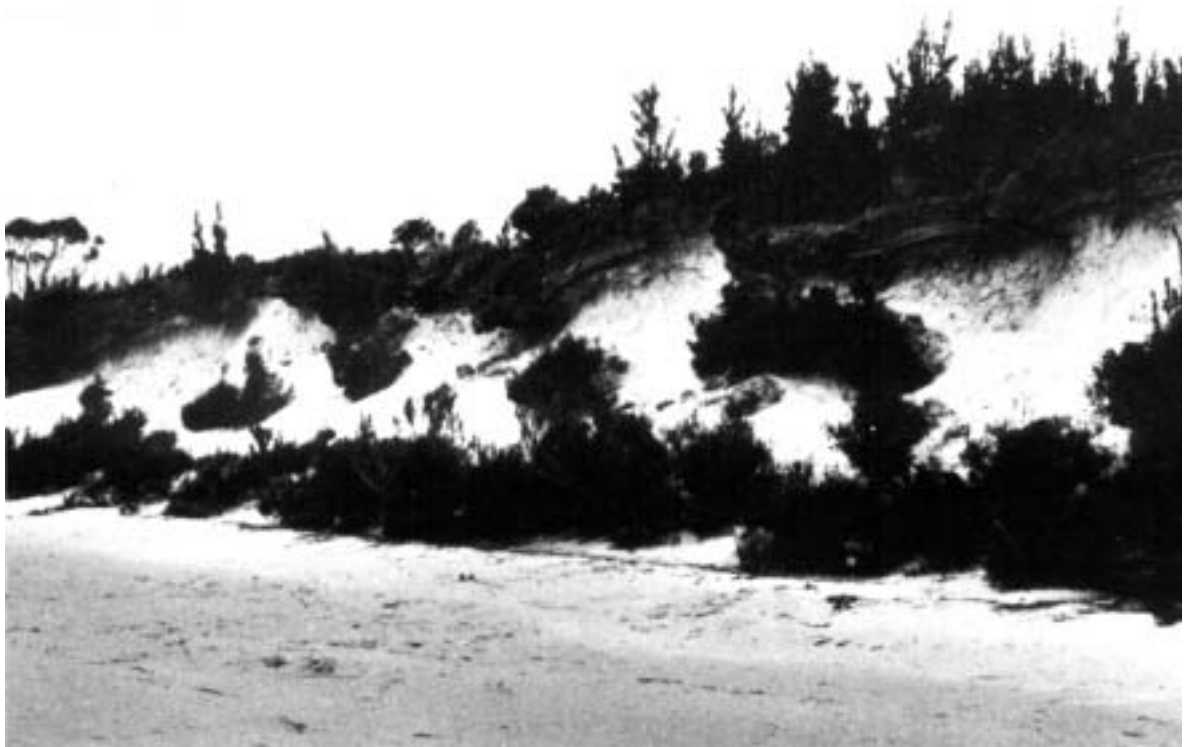
Figure 5b: Naturally-eroded condition of the western face of the Pedder dune prior to filling of the Huon-Serpentine Impoundment (from Johnson 1972, p. 29).

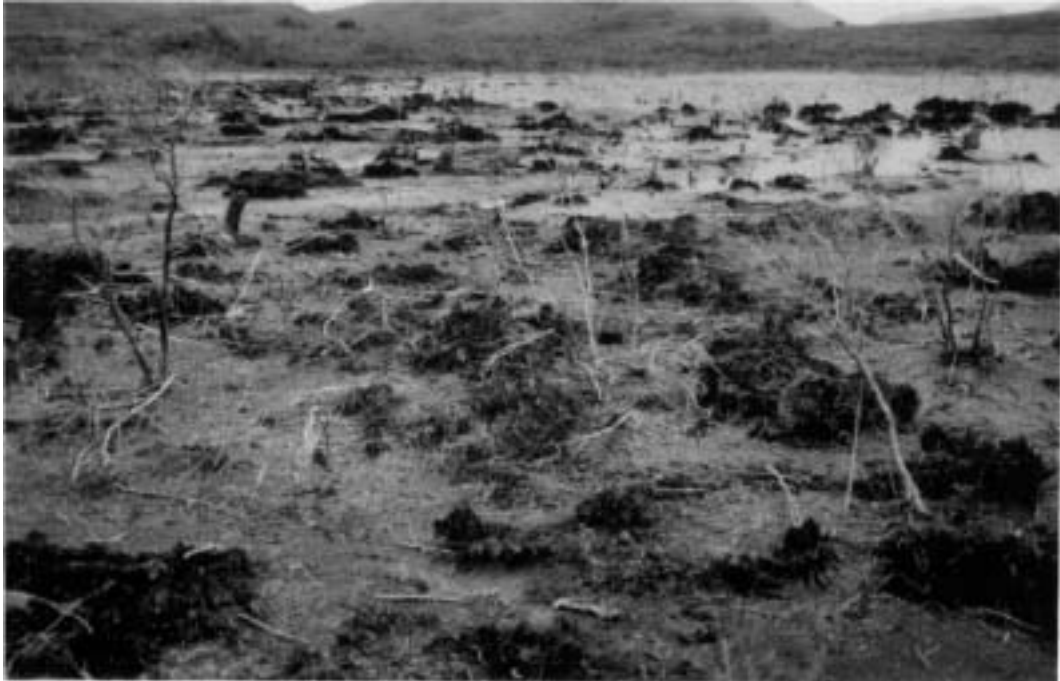
Figure 6: Degree 2 damage to reservoir perimeter. Inundation has killed the vegetation but wave action on the shallow lake margin has been insufficient to fragment the root mat and peat more than two decades after the reservoir was filled (photo: K. Kiernan, 1999).

The scoring system adopted was: (1) only partial death of vegetation at the impoundment margin and no exposure of regolith; (2) vegetation death but no evidence of regolith exposure (Figure 6); (3) discontinuous visible damage (Figure 7a, b, c); (4) continuous visible erosion (Figure 8a, b, c); and (5) severe damage due to dam construction activities. It should be recognised that the use of vertical air photos means that the visibility of erosion is reduced where the erosion scarp is steepest and potentially highest. To some extent this problem is compensated for by the fact that the photos are in colour and the white quartzite scars show up very clearly on them. However, one of the aims of the ground-based and water-based inspections was to obtain some impression of the extent to which erosion may be under-represented as a result of deficiencies in the air photo perspective. Although only a limited number of sites were ground-truthed, in no case has the erosion proved to be more severe than what was suspected from the air photo interpretation. This is probably partly due to the limited amount of very steep ground, the impoundment being shallow over the valley floors and its surface impinging for the most part on relatively gentle footslopes.

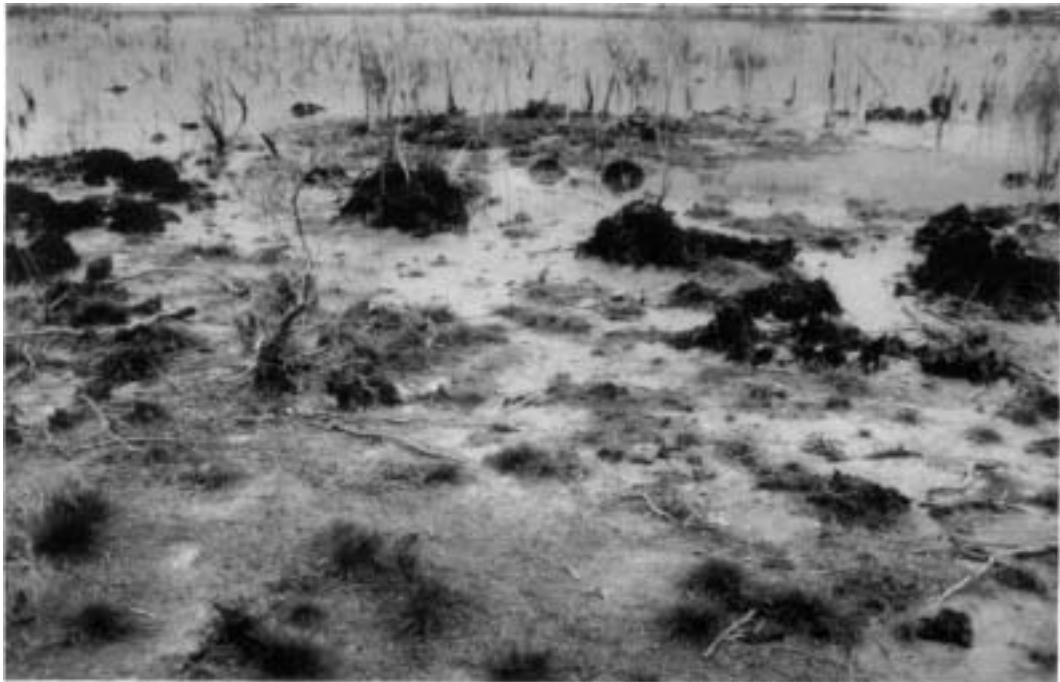
Figure 7a: Degree 3 damage. Minor peat erosion in an embayment on the reservoir perimeter. The limited erosion and frequent exposure here allows some of the remaining vegetation to remain alive (photo: K. Kiernan, 1999).

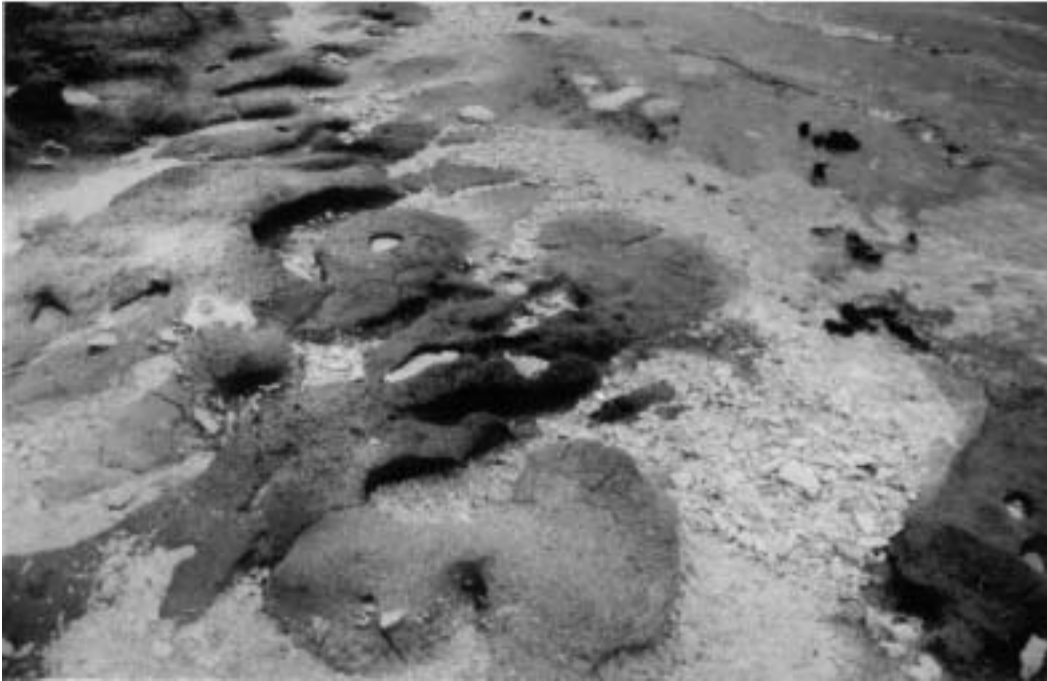
Figure 7b: Degree 3 damage. The pattern of peat erosion here involves the development of shallow channels up which gravels are swept and deposited on the peat further inshore. In more severely affected areas confluence of the erosion channels proceeds to the formation of remnant peat islands (photo: K. Kiernan, 1999).

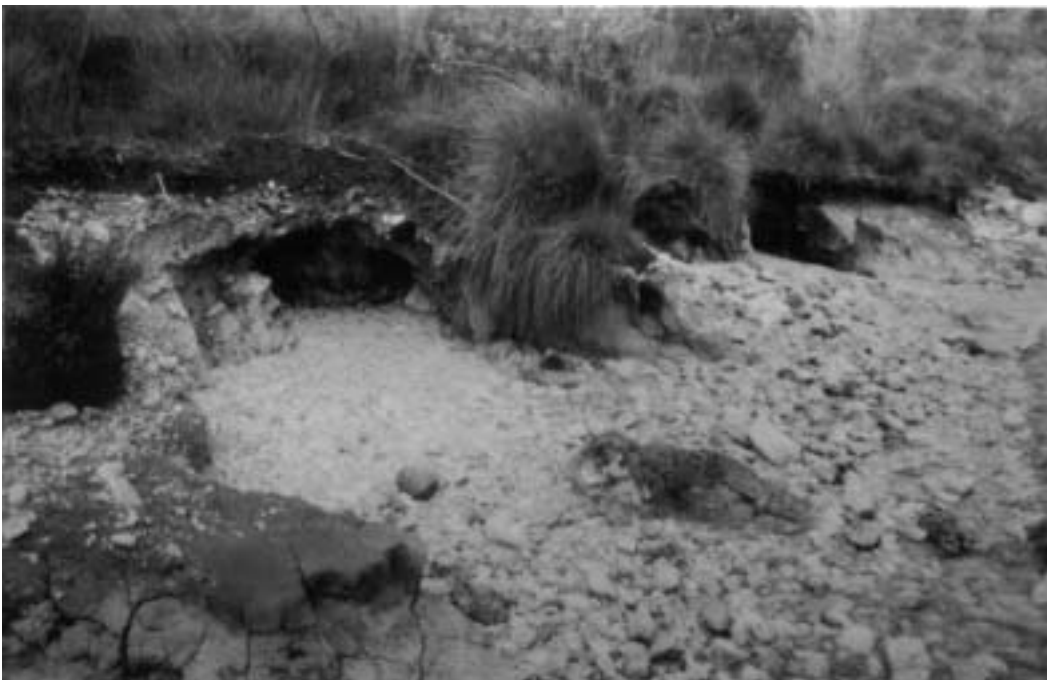
Figure 7c: Degree 3 damage. Cliffing of sandy regolith in embayments between remnant peat promontories (foreground). Minor tunnelling in loose regolith beneath peat at head of embayments (photo: K. Kiernan).

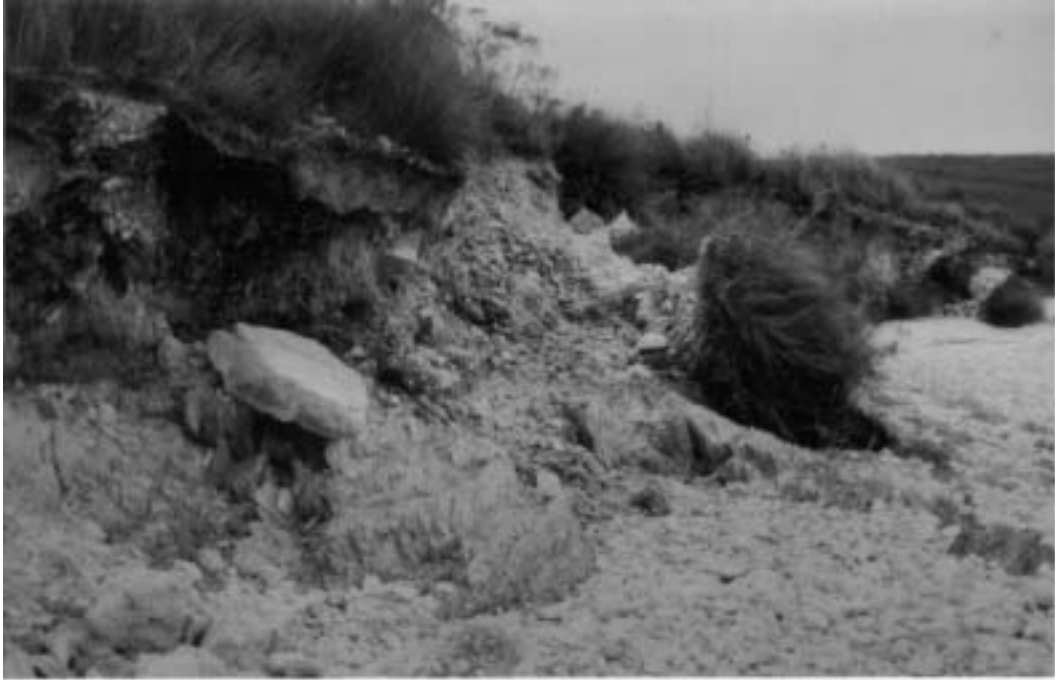
Figure 8a: Degree 4 damage. Scarp about 1m high eroded in surficial sediments overlying bedrock on a steep, exposed shore. Loose material from the regolith has been drawn down onto the lake margin by backwash. Deeper erosion is inhibited by the shallow bedrock (photo: K. Kiernan).

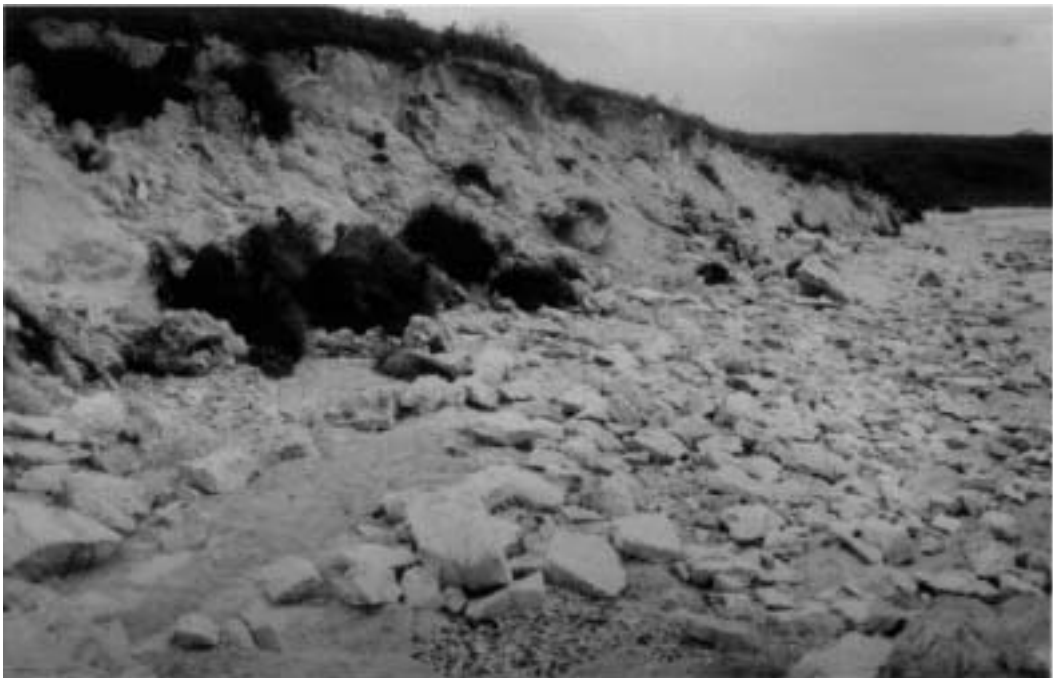
Figure 8b: Degree 4 damage. Scarp 2 - 3m high formed entirely in surficial sediments east of Scotts Peak Dam. This major cliffing is at the most severely eroded site identified during this survey, and is located at the exposed southern end of the reservoir. The blocks and cobbles in the foreground have been reworked from the regolith with the larger rocks piled towards the back of the beach by wave action (photo: K. Kiernan).

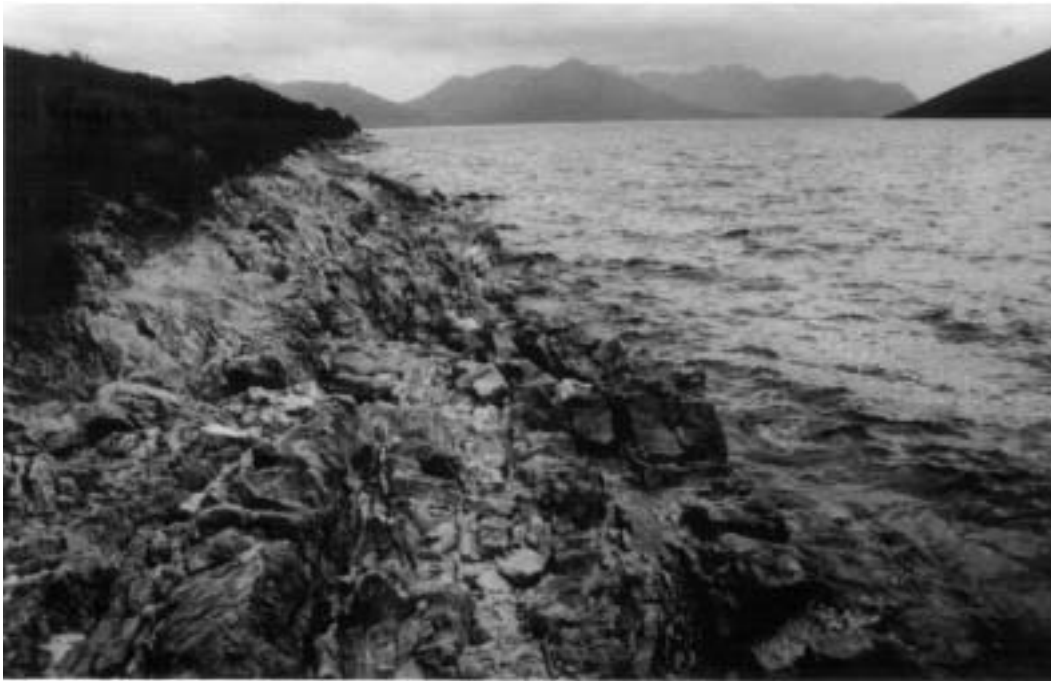
Figure 8c: Degree 4 damage. Stripping of shallow peat to expose a bedrock shore on a steep margin of the reservoir west of the Scotts Peak Dam exposed to the full fetch of the largest waves (photo: K. Kiernan).

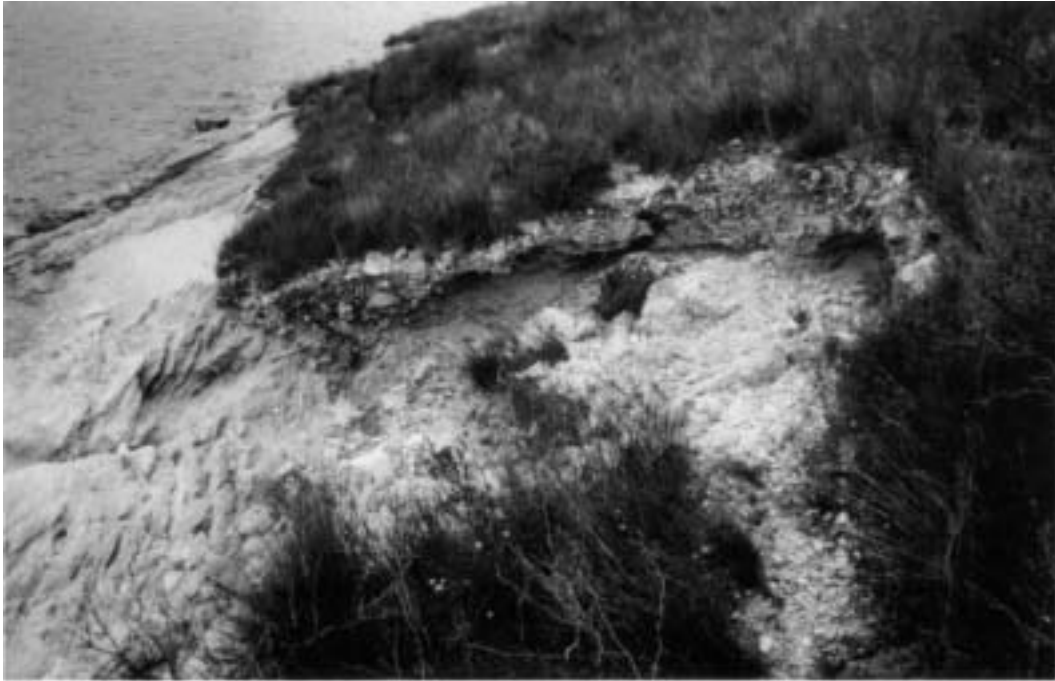
Figure 10: Small landslide on reservoir perimeter west of Scotts Peak Dam, caused by wave erosion removing toe support from slope deposits. Slope failures of this kind appear uncommon around this reservoir (photo: K. Kiernan).

Ground inspection revealed that the most serious erosion damage comprises the stripping of regolith from bedrock slopes, exposing a rock scarp. Such damage is focussed primarily on steep slopes, especially on ridges that project into the impoundment. Where steep linear slopes or embayments have been exposed to the full fetch of the waves west of Scotts Peak Dam, the regolith has been quarried very effectively, exposing bedrock faces up to 3m high (Figure 8c). Material has been quarried out from joints previously widened by weathering to produce small caves that sometimes extend 2-3m. The regolith removed in these areas consists primarily of slope deposits. Only very rarely is there evidence for the removal of toe support from these slope deposits having

caused landslides that have migrated upslope (Figure 10). This is due to the generally low angles and lengths of the slopes and to the nature of the component clasts and matrix of the surficial sediments. Since these have been stripped to well above the surface of the impoundment there is no evidence to suggest that the water itself provides any sort of buoyant support to the material that would be lost when the dams are drained, threatening slope failure.

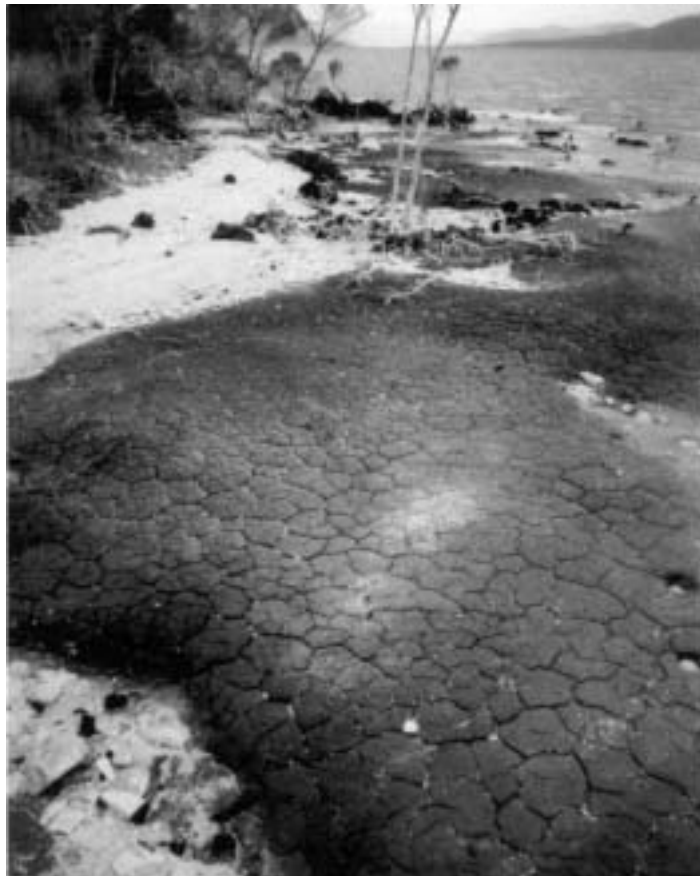
Figure 11a: Peat soil survival despite an appearance of erosion. Intact peat on the southern perimeter of the impoundment. Despite apparent exposure to the full fetch down the lake the shallow shore reduces wave action. The intact peat exhibits desiccation cracks that can form receptacles for seeds and nutrients. The white material inshore of the peat is not regolith exposed by peat erosion, but merely a thin veneer of gravel deposited on the peat by wave action. The presence of gravels implies they have been eroded from elsewhere. Since there is no erosion of the peat on the shore it is likely that longshore drift has been involved, but erosion from deeper water forward of the peat cannot be discounted entirely (photo: K. Kiernan).

The exposed peat has sometimes become patterned by desiccation cracks (Figure 11a), which are likely receptacles for seed and nutrient capture and hence foci for revegetation when the reservoir is drained. A similar pattern of regrowth from peat desiccation cracks has been observed on the floor of Lake King William and some other artificial reservoirs when their floors have been exposed during protracted periods of lake drawdown.

From the air photographs some sites appear eroded but the conspicuous white material only thinly mantles peat that remains intact with the potential to provide a growth medium for plants when the reservoir is drained. These uneroded sites cannot be differentiated from areas of erosion into the substrate without detailed ground inspection. Hence, it is likely that some proportion of those areas of the reservoir perimeter scored from the airphotos as having been damaged to degree 3 or 4 will in reality be damaged no more than degree 2 (Figure 11a, b, c).

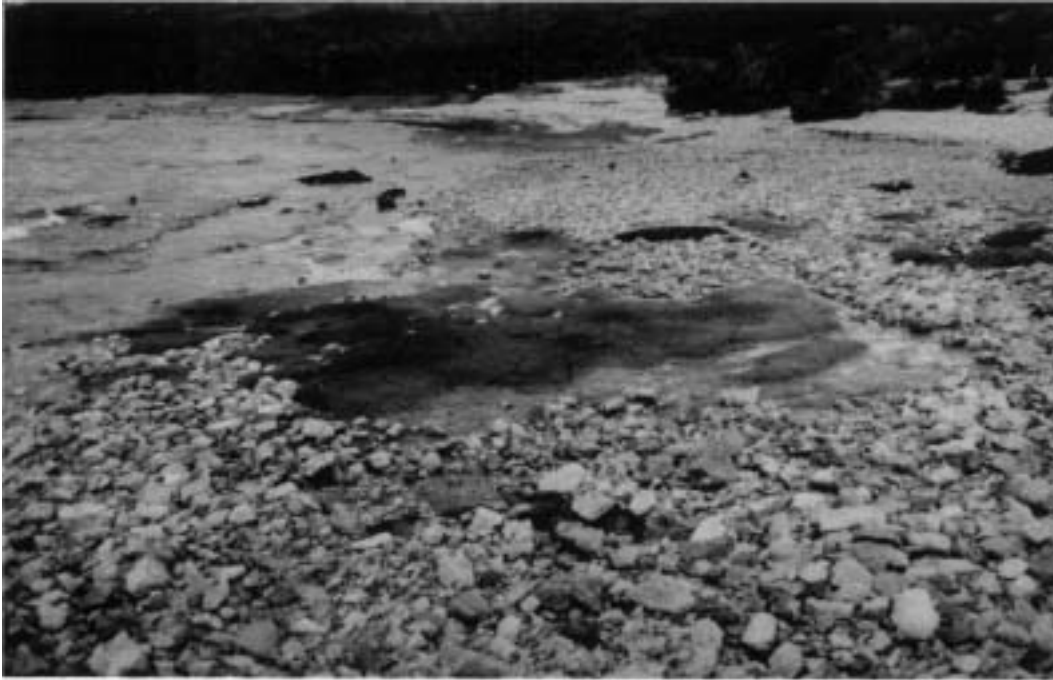
Figure 11b: Intact peat thinly overlain by gravels and cobbles deposited by waves along the exposed southern margin of the impoundment. Again, the peat remains available as a potential growth medium for plants when the impoundment is drained (photo: K. Kiernan).

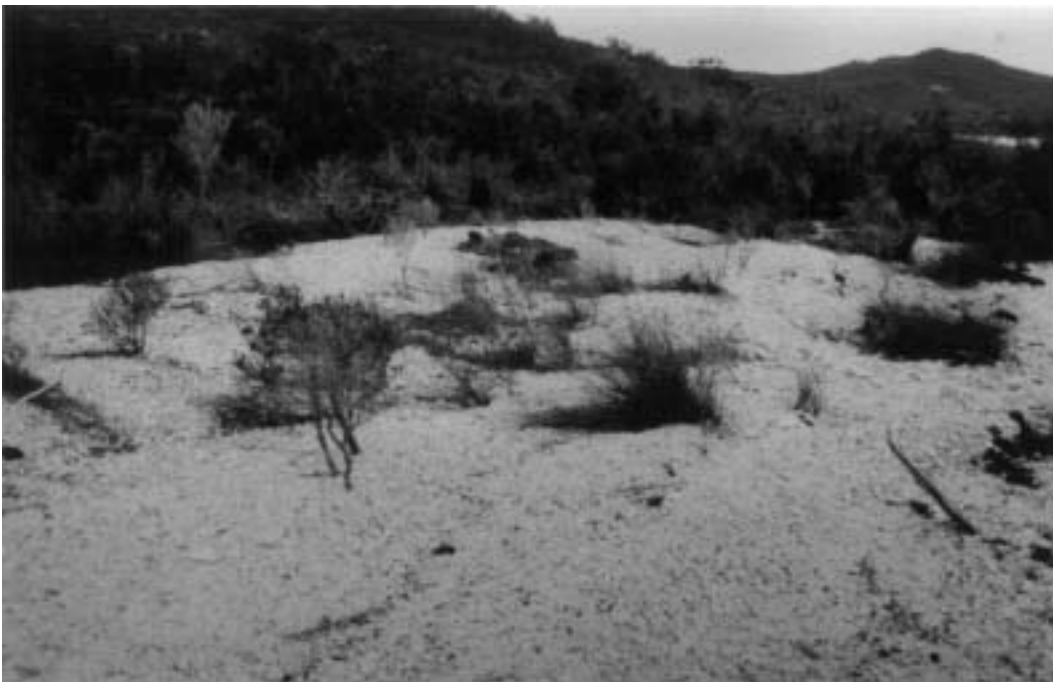
Figure 11c: Formation of small beach ridges has here involved the dumping of gravels on living vegetation by wave action. Again the eroded appearance is deceptive, and a viable medium for plant growth remains intact beneath the sediment. Similar small storm-beach ridges encroaching onto living vegetation could be found along parts of the southern shoreline of the original Lake Pedder. The coarse calibre of the lakeshore sediment in this and earlier photographs is typical, and in contrast to pre-dam promises that sandy beaches equivalent to that at the eastern end of the original lake would rapidly form to replace it. This was never a serious proposition because the source of the Pedder beach was fine wind-deposited sand naturally eroded from the face of the Pedder dune each winter and spread onto the floor of the original lake basin. No similar large source of windblown sand is available around the margin of the artificial Huon-Serpentine Impoundment (photo: K. Kiernan).
